AERO ADVENTURE AVIATION, INC

SAFETY DIRECTIVE AV II – 0001

INSPECTION AND/OR MODIFICATION OF CONTROL TUBE THREADED INSERT ATTACHMENT

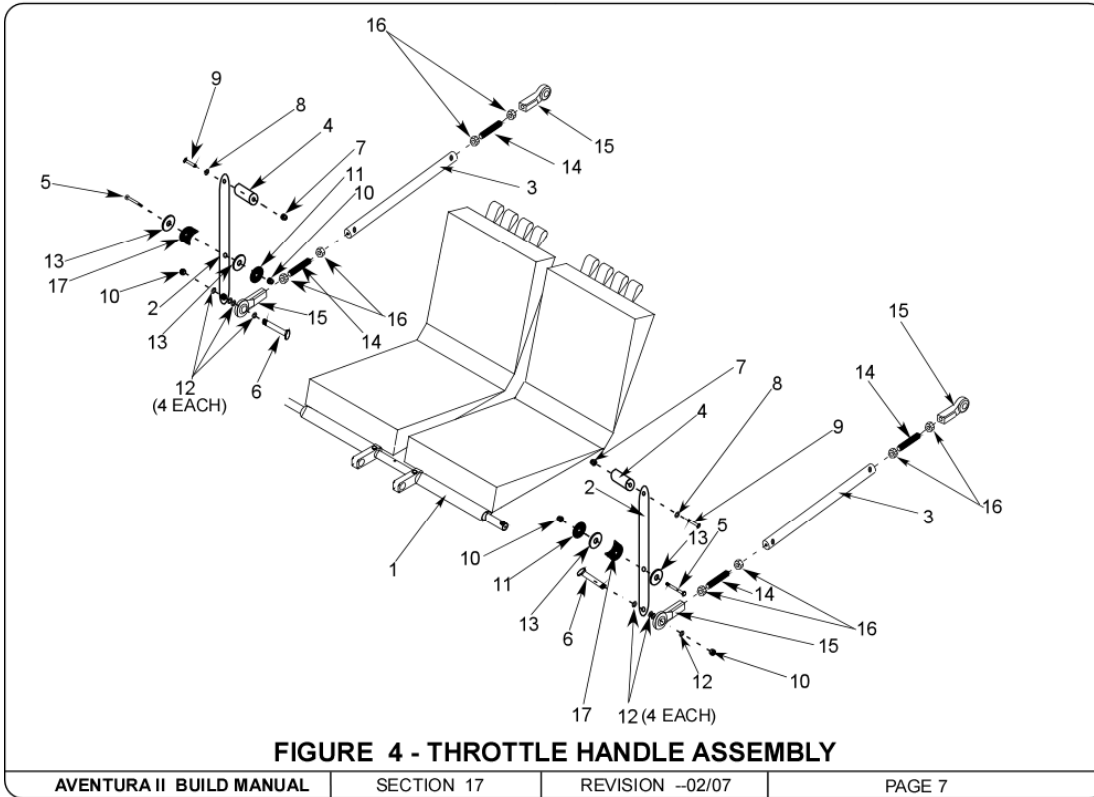
Figure 1

Inspect the Left and Right Dual Throttle Control Tubes (see Fig. 1, part 3) to ensure that the Threaded Inserts are secured to the tube with a solid rivet or an AN3 Bolt and Nut (see Fig. 3).

2.2.1) Any control tube inspected IAW (2.1.1, 2.1.2 and 2.1.3) where the Threaded Insert is not secured with a solid rivet or an AN3 Bolt and Nut must be removed, modified and reinstalled by an authorized mechanic or repairman. Modification will include the installation of a solid rivet or an AN3 Bolt and Nut at each Threaded Insert connection.

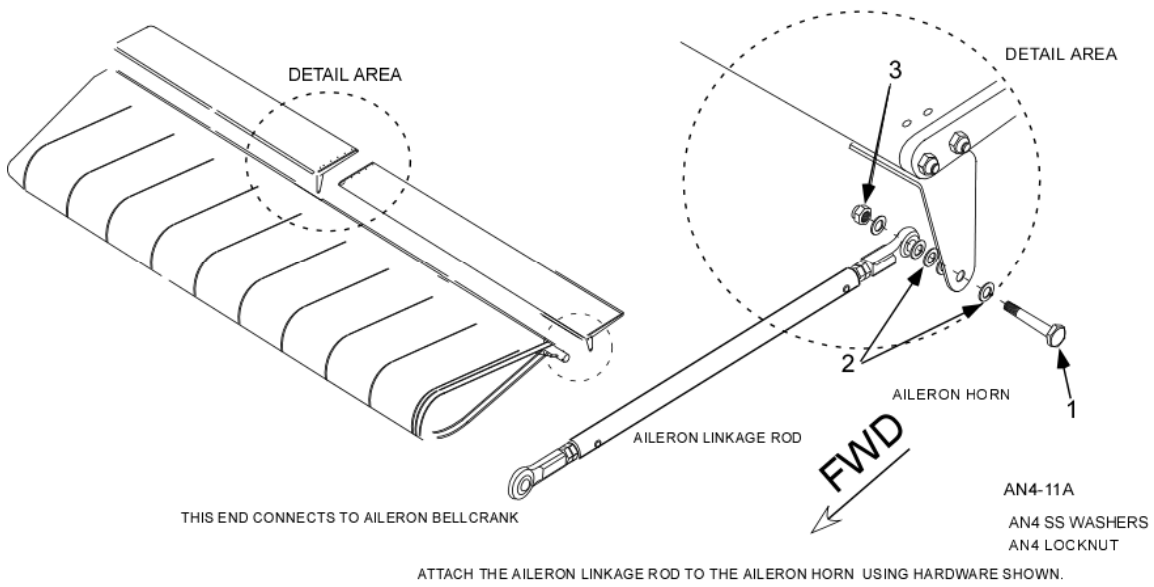
Figure 2

Inspect the Left and Right Aileron Control Tubes (see Fig. 2, Aileron Linkage Rod) to ensure that the Threaded Inserts are secured to the tube with a solid rivet or an AN3 Bolt and Nut (see Fig. 3).

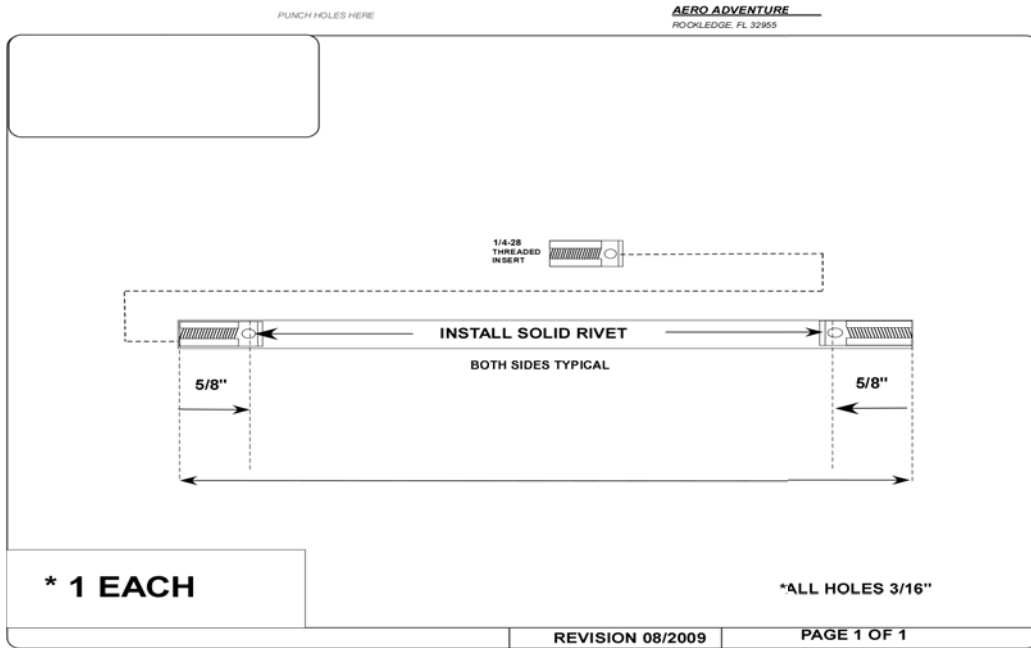
Figure 3

Field experience has shown that connection of the ¼ - 28 threaded insert (see Fig. 3) on certain control tubes require modification due to the following: Threaded Insert can separate from the control tube.

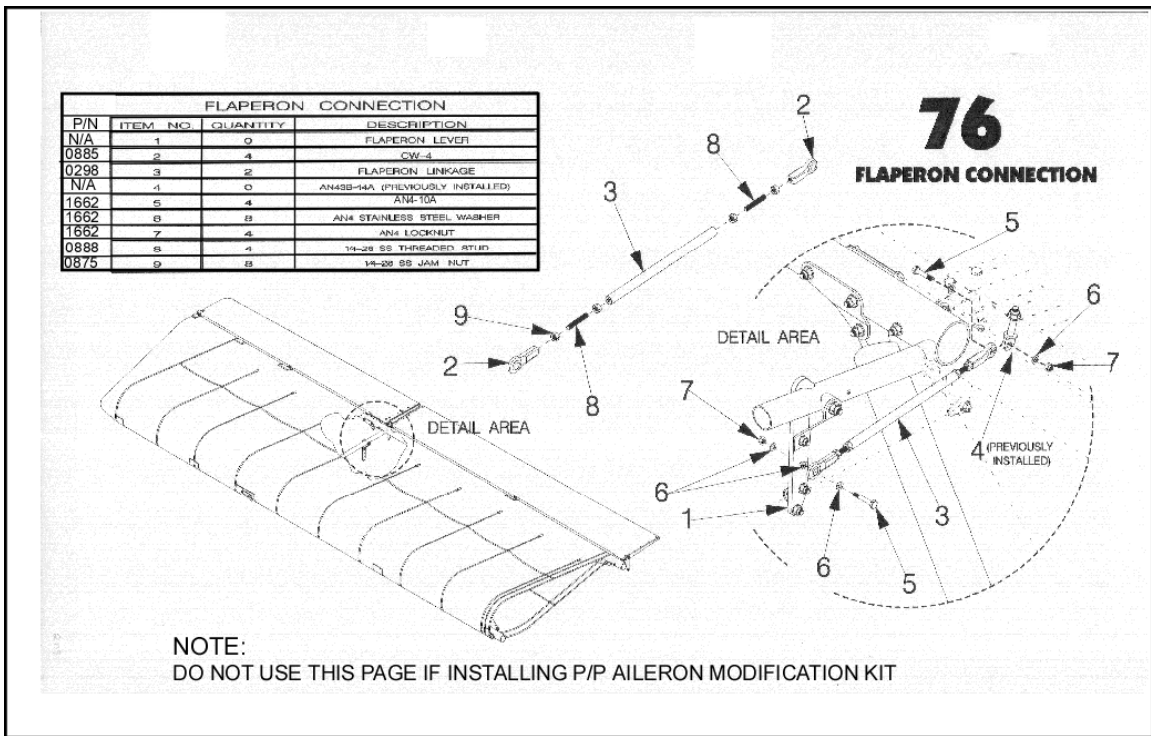
Figure 4

Inspect the Left and Right Flaperon Linkage Control Tubes (see Fig. 4, part 3) to ensure that the Threaded Inserts are secured to the tube with a solid rivet or an AN3 Bolt and Nut (see Fig. 3).
